SELLENRIEK DAM

FRANKLIN COUNTY, MISSOURI

MO. 31048

**PHASE 1 INSPECTION REPORT
NATIONAL DAM SAFETY PROGRAM**

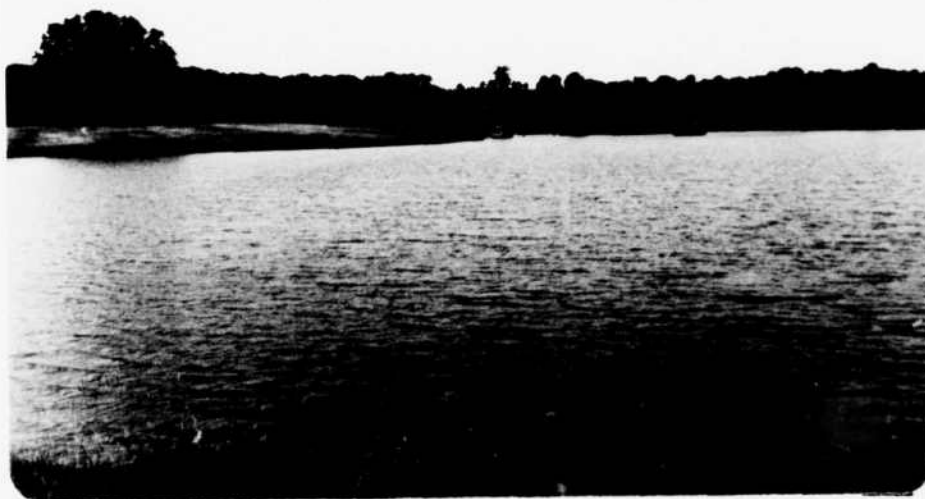
d. Reservoir Area. The area surrounding the reservoir appears to be well grassed. Some erosion was noted around the shoreline but nothing significant. A gravel armored beaching slope has developed in portions of the shoreline. The reservoir water was clear.

PHOTO NO. 8 - LOOKING UPSTREAM ACROSS LAKE
